Bayside Baycreek CDD Lake Management Report January 2018

SOLitude Lake Management

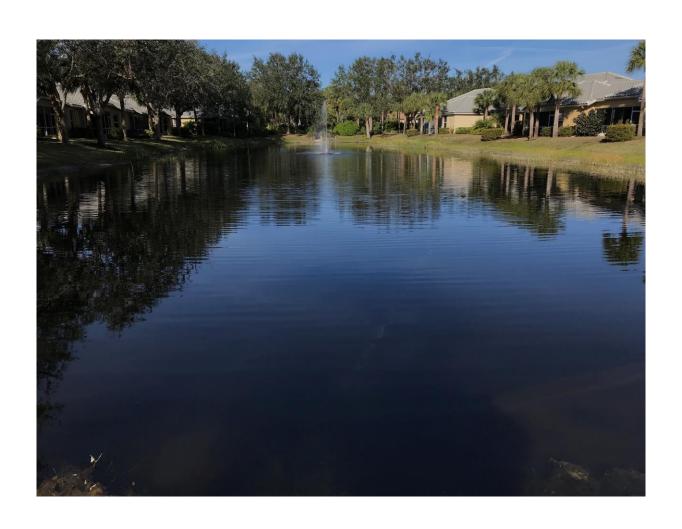
C1 – Longlake Village. Looks good, other than dying bladderwort fragments

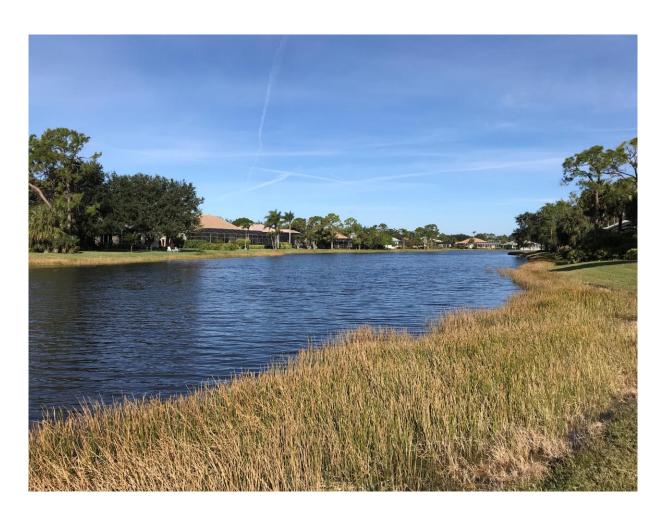
C3 – Longlake. Looks great. We were worried about the beneficial spikerush being thinned as we got bulrush back under control. Apparently, no matter what, in this lake, the spikerush always comes back thick.

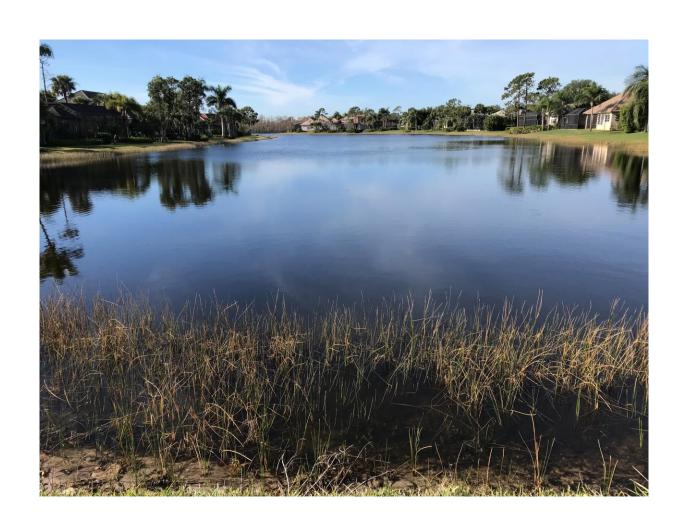
C4 – Longlake/ Heron Marsh. Lake looks great other than minor algae

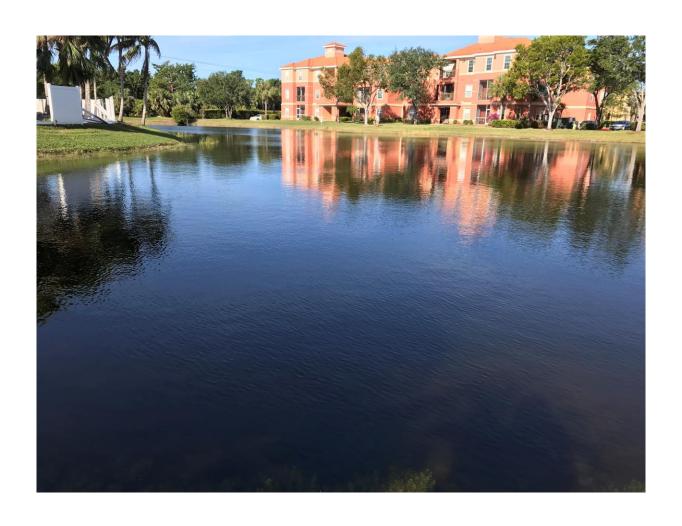
E16 – Villas of Pelican Landing. Looks good other than dying bladderwort fragments. This is a lake where beneficial spikerush did not recover as well from clean up activities

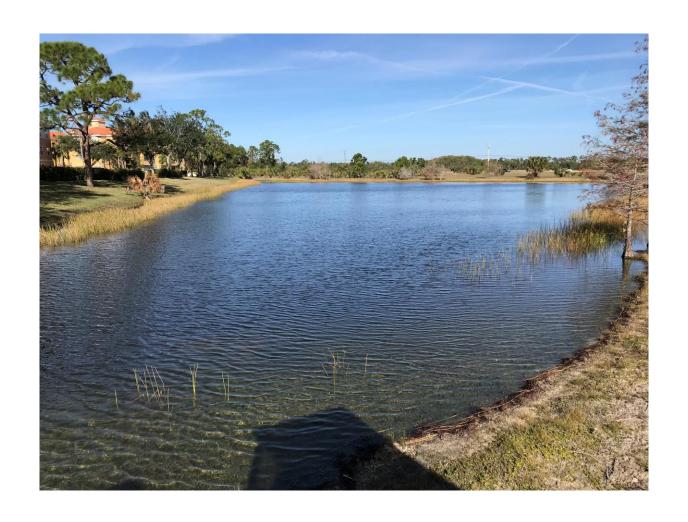
E18 – Villas of Pelican Landing. Looks great, but a lot of chara on the bottom. Needs attention

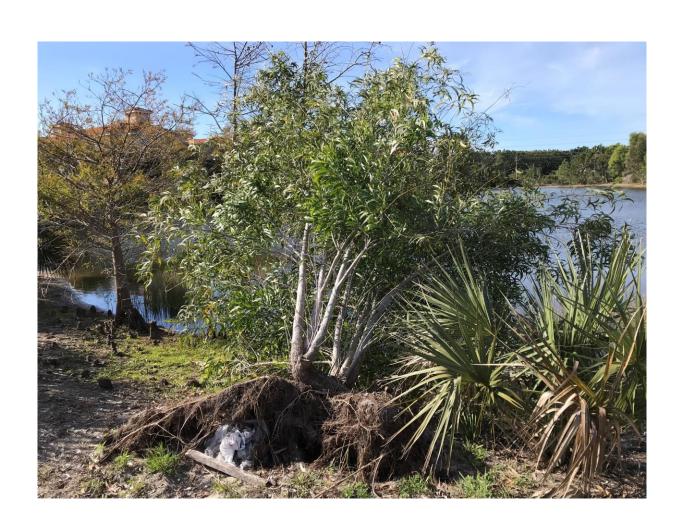
E14 – Villas of Pelican Landing. Earleaf Acacia tree. Not in our area, but hurricane damage is making it fall towards the lake. Exotic tree anyway, should be removed.

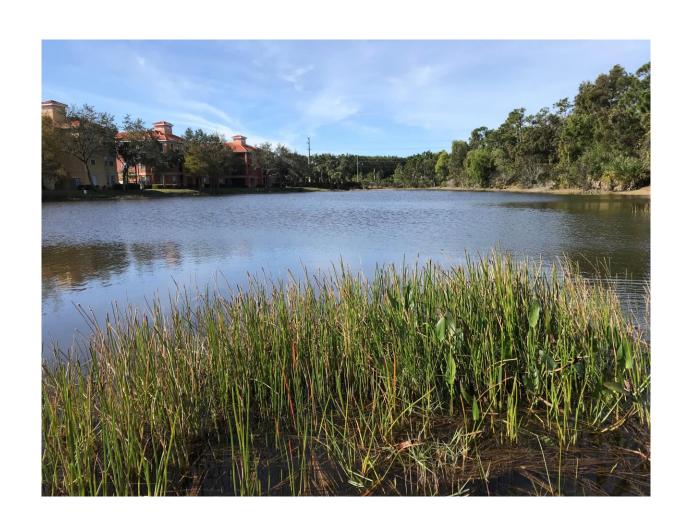
E14 – Villas of Pelican Landing. Looks good

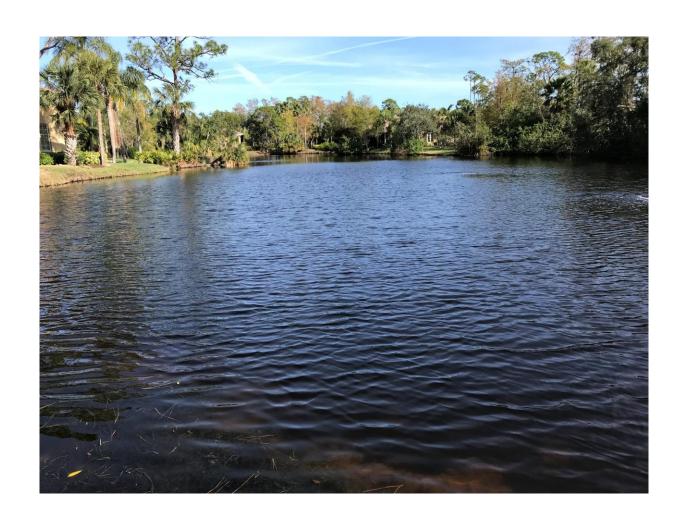
F-16 Las Palmas. Looks visibly good, although there is still significant slender spikerush that is dying, but not gone.

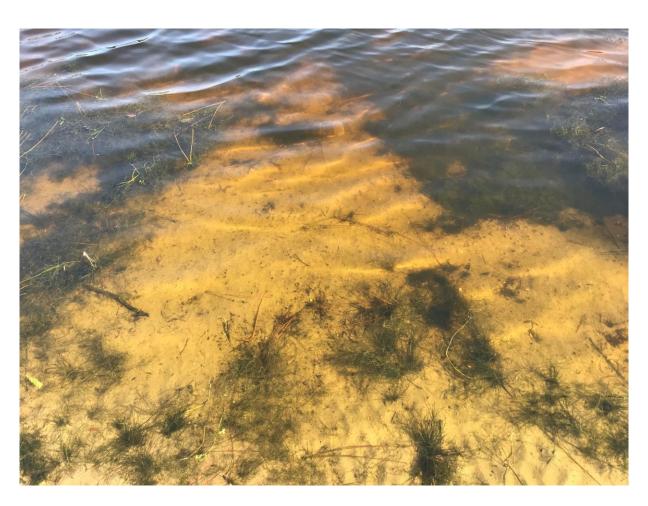
- The visual impact from this product on lake F16 is vivid. This will be evident in pictures that follow.
- Based upon discussion of Johnson Engineering's report on muck in the lakes they are studying, and the
 concern over substantial build up, we have provided quotes to make certain the aeration systems in
 those lakes are creating optimal oxygen levels. We also have provided quotes for adding Eco Sox
 bacteria to those lakes.

Close up of F16. Our applicators have always called this swamp lake because it is shallow, and very dark bottomed, presumably from muck. The dark areas in this picture are dying spikerush. The soil is typically black in this lake. Seeing this sand after applying muck pellets was a shock.

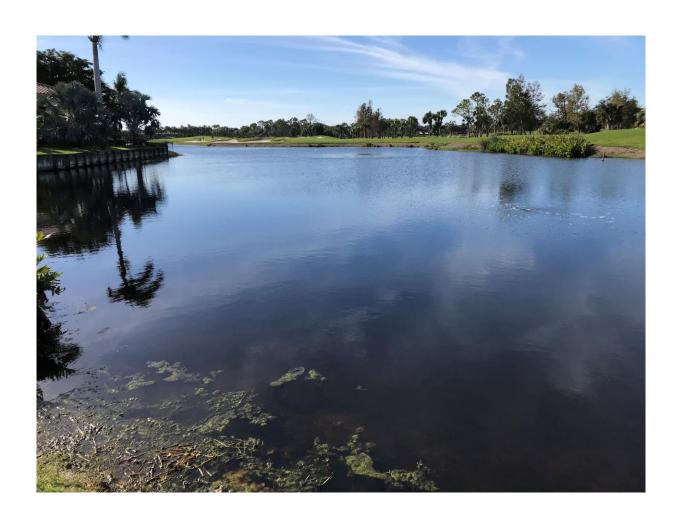
E7 – Colony Clubhouse. Algae

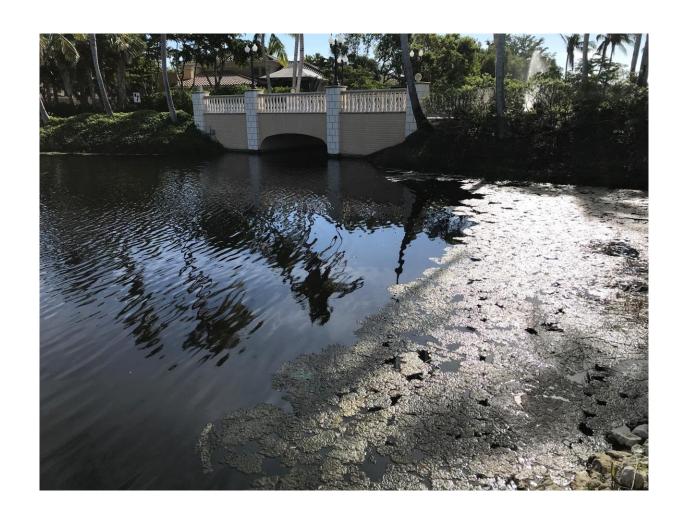
F1 – Las Palmas. Resistant algae blown up in one corner

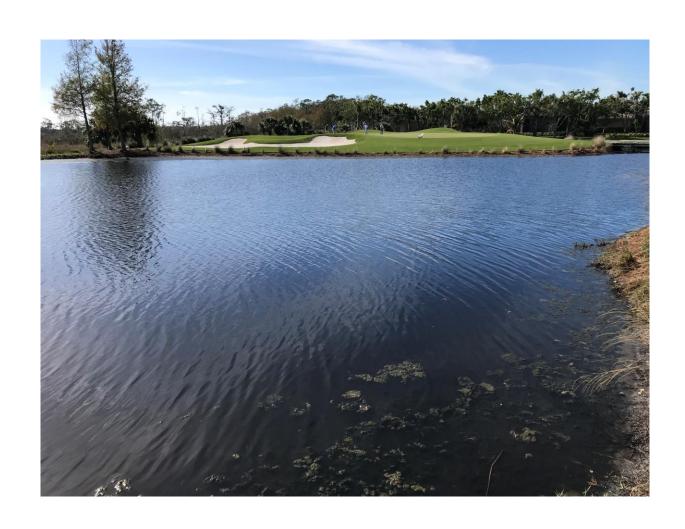
F6 – Las Palmas. This lake has been a problem for algae. The coves on the east end are very shallow, and golf course reconstruction has limited our access.

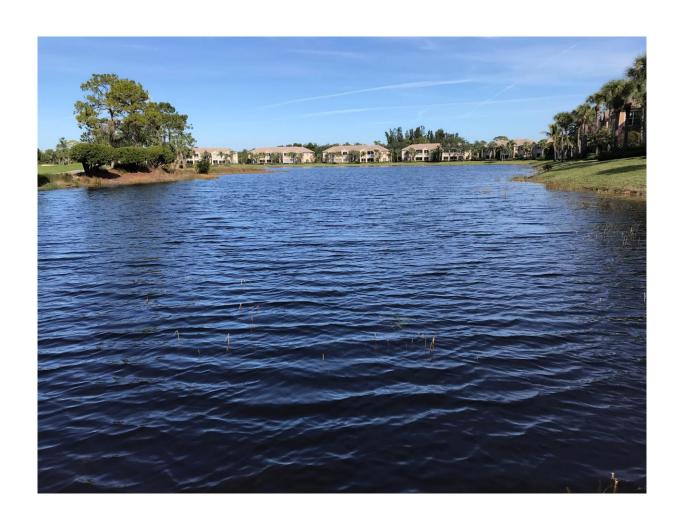
F8 – Merano. This lake had significant bacopa which was discussed last month. Looks pretty good with only limited bacopa issues

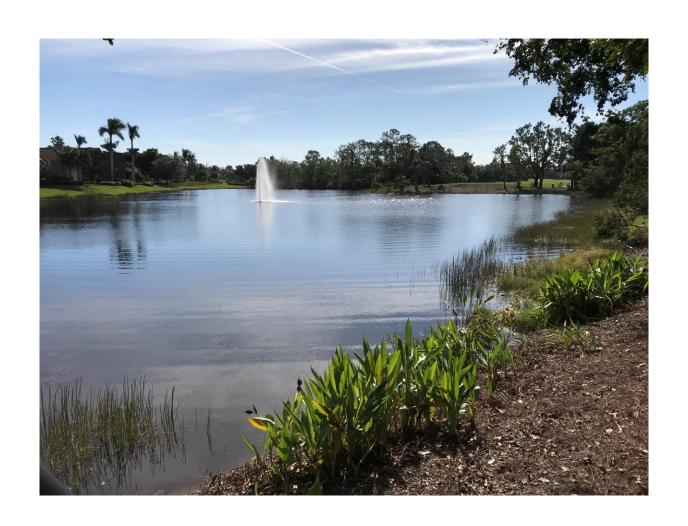
F4 – Tuscany Isle. Some torpedograss is present

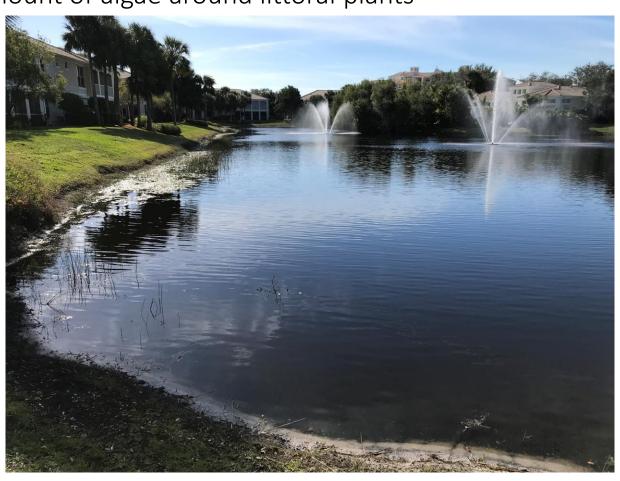
E5 – Sandpiper Isle. This lake has been frustrating lately. This lake was a major algae producer years ago. We fixed it for a long time with phoslock treatment. It has become a problem again. We use littoral plants to minimize nutrient in theory. Some times, algae seems to associate with the littoral plants. In this lake, areas with no plants look good, but there is a decent amount of algae around littoral plants

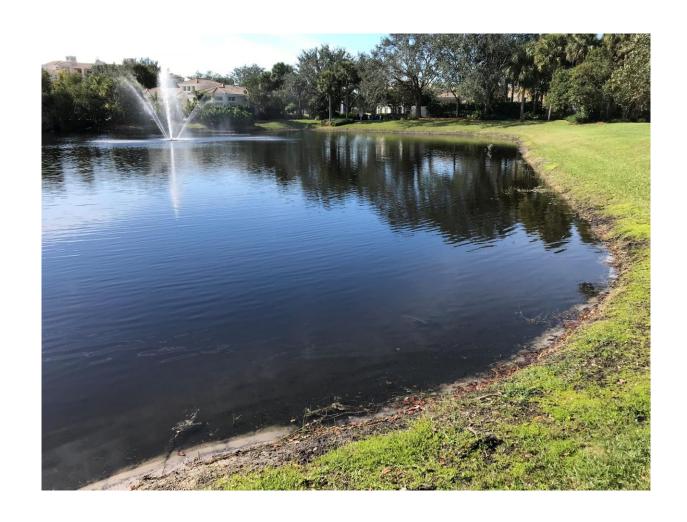
E5 from same photo point, looking other direction. No plants, clean look.

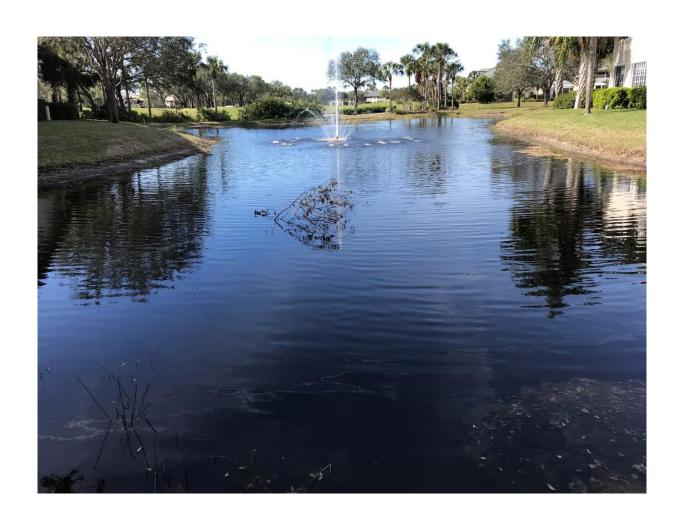
E4 – Sandpiper Isle/ Palm Colony. Dying bladderwort

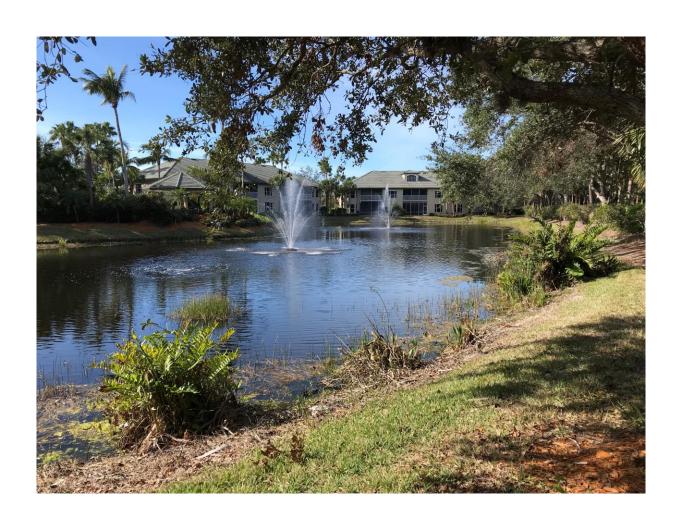
E2 – Palm Colony. Slender Spikerush, Bladderwort and algae

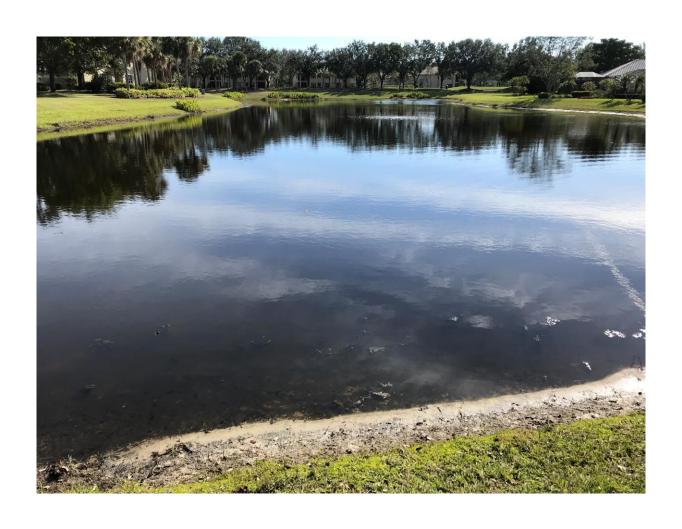
A18 – Capri. Resistant algae

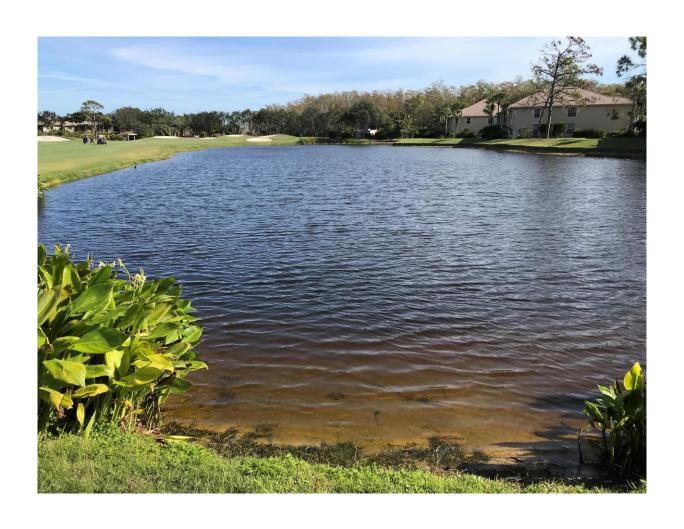
A6 – Sawgrass. Looks good

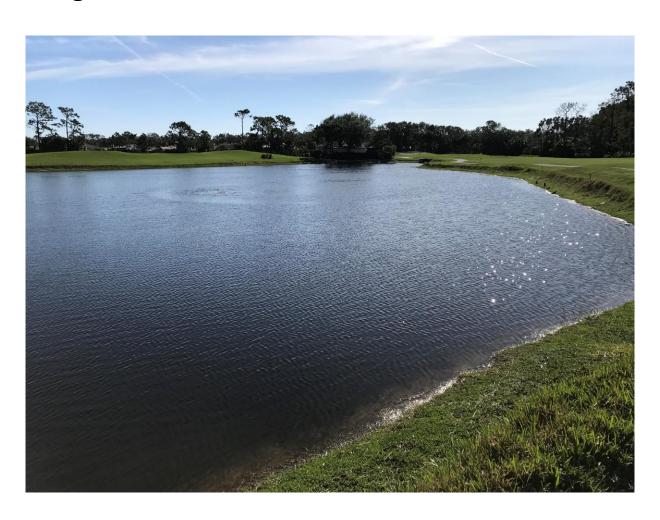
D7 – Pelicans Nest irrigation lake. This lake used to be one of the worst lakes in the community. Although there is slender spikerush in the lake, the grass carp keep it in check. The lake looks great

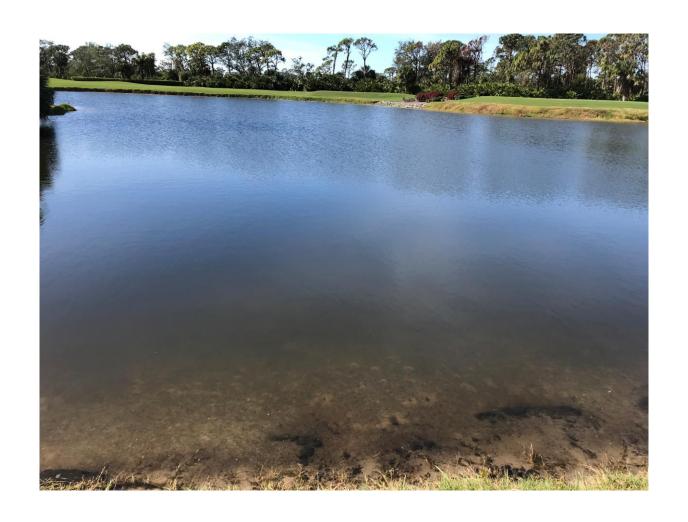
D8 – Pelican Nest golf course recharge lake. The cleanest I have ever seen this lake. There is torpedograss adjacent to the wetland that needs attention

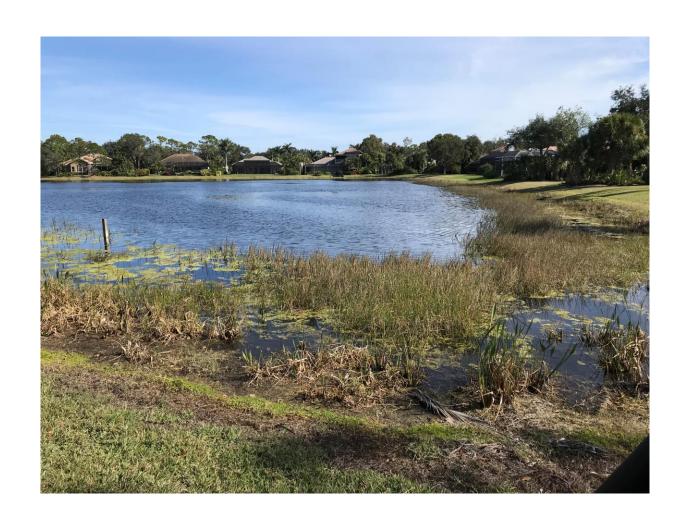
B2 – Lakemont. Algae

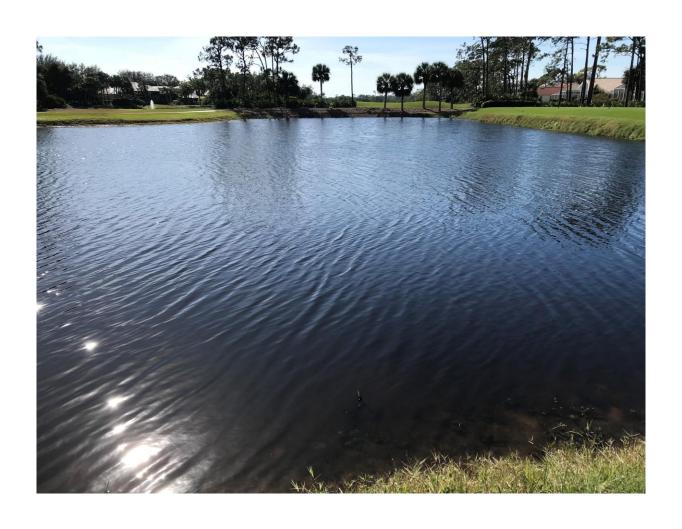
A10 – The Ridge. Looks good

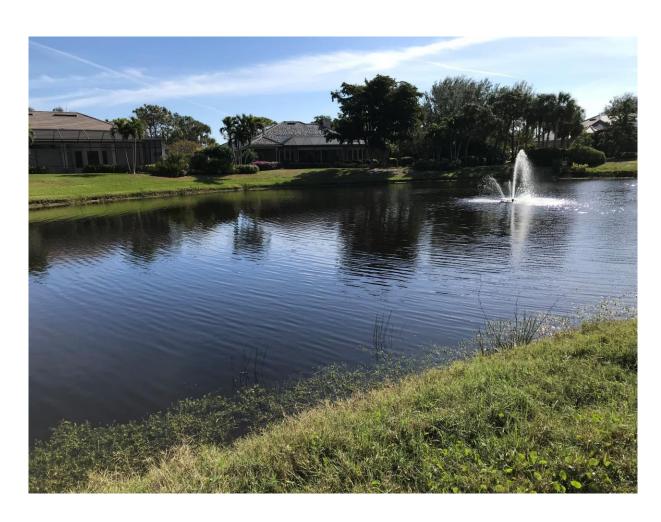
D10 – The Ridge. Looks good other than bacopa which we typically leave as a beneficial ground cover, but it is getting out of hand in this lake. Fountain has challenges.

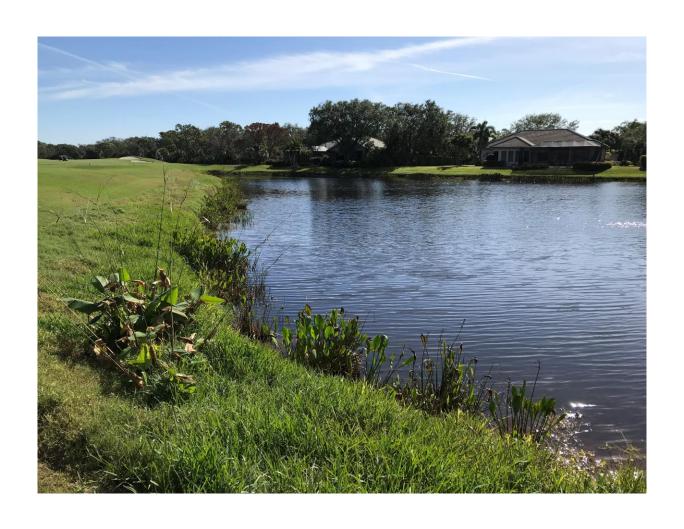
D11 – The Ridge. Looks good

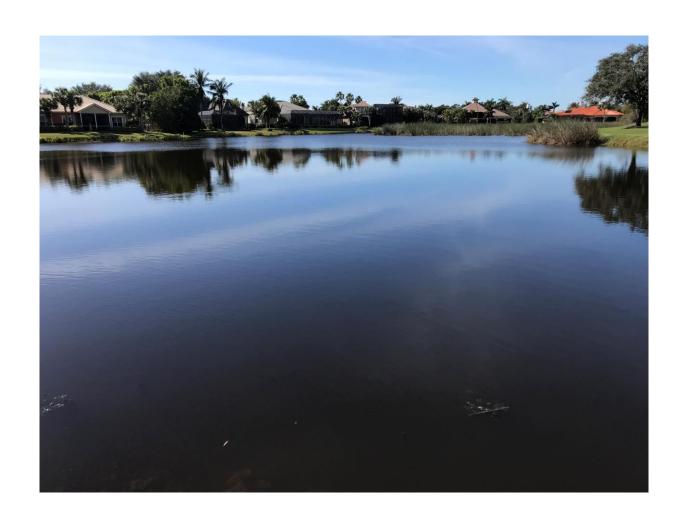
D8 – Baycreek. Some algae

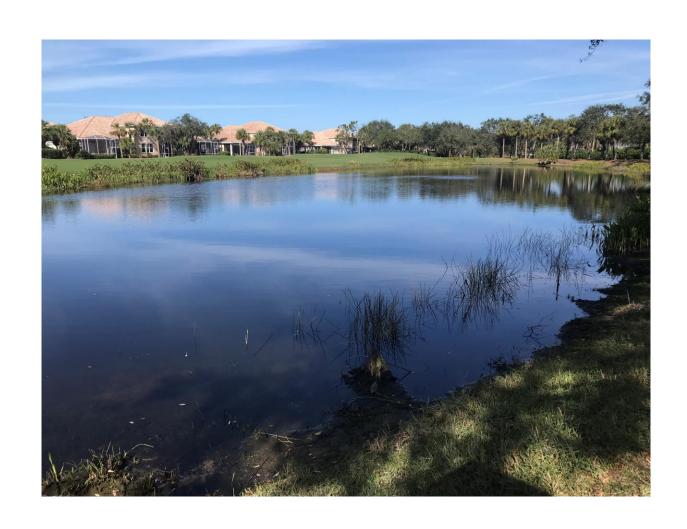
D5 – Baycrest. Looks good

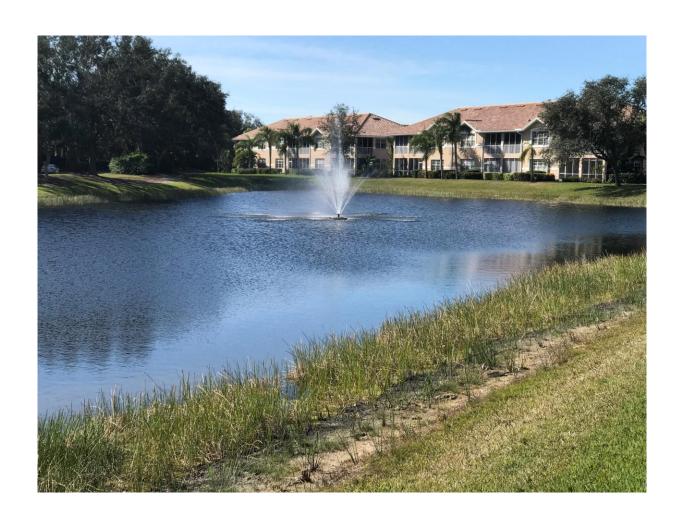
D3 – Southbridge Looks good

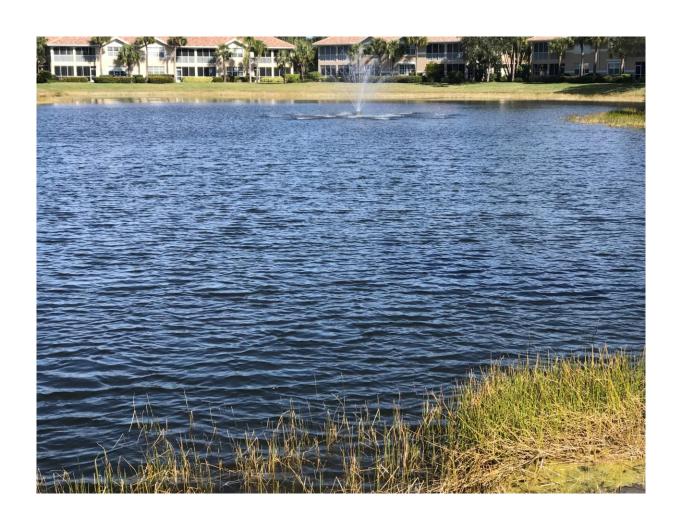
D3A – Southbridge. Looks great

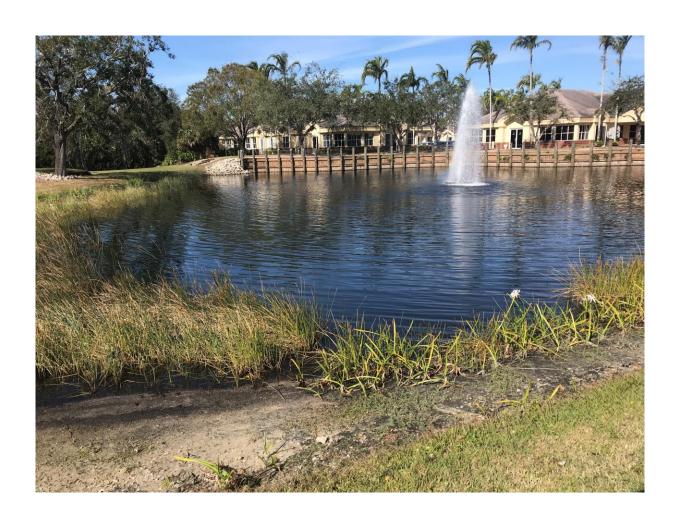
B7 Looks great

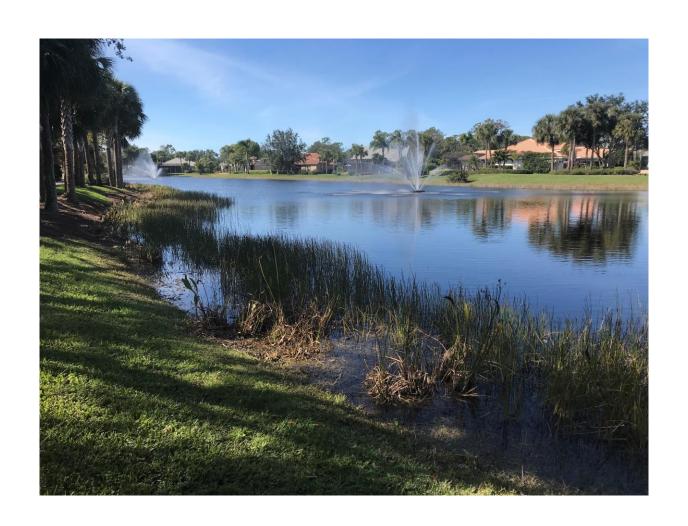
B3 – Main entrance. Looks very good.
